Malago River Executive Summary

Project aim

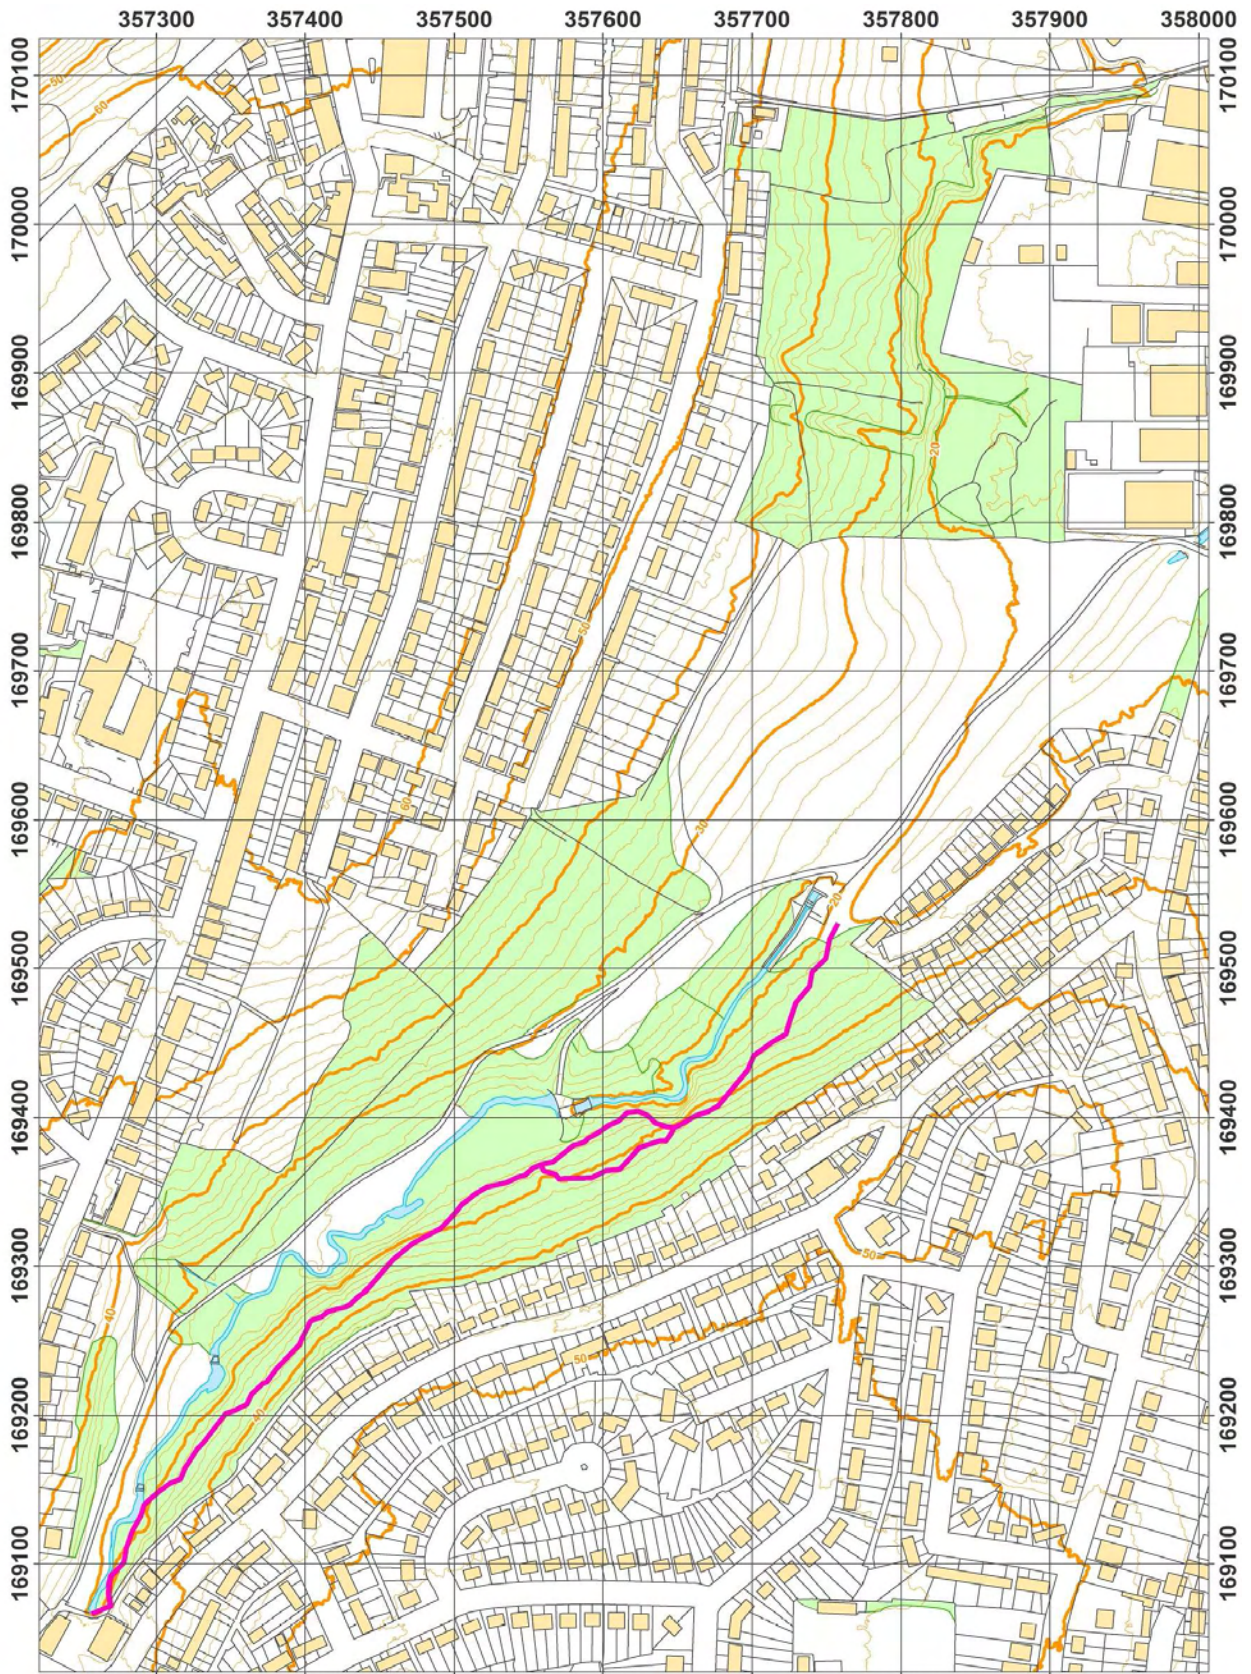
We used handheld GPS units to map the footpath on the eastern side of the stream. This was then merged with existing map data¹, and contour data derived from LiDAR (Light Detection And Ranging) data² using a GIS software (ArcMap). We then added a 100m grid to aid with surveys in the future. A Google Drive folder with JPEG files of this map and the ArcMap project file has been shared with the MVCG. A scaled down preview of the map with the new path highlighted is attached at the end of this document.
